Exterior Architectural Finishes in Puerto Rico: The Painting Traditions of Guayama's Vernacular Architecture

Betty L. Prime
University of Pennsylvania

Prime, Betty L., "Exterior Architectural Finishes in Puerto Rico: The Painting Traditions of Guayama's Vernacular Architecture" (2011). *Theses (Historic Preservation)*. 164.
http://repository.upenn.edu/hp_theses/164

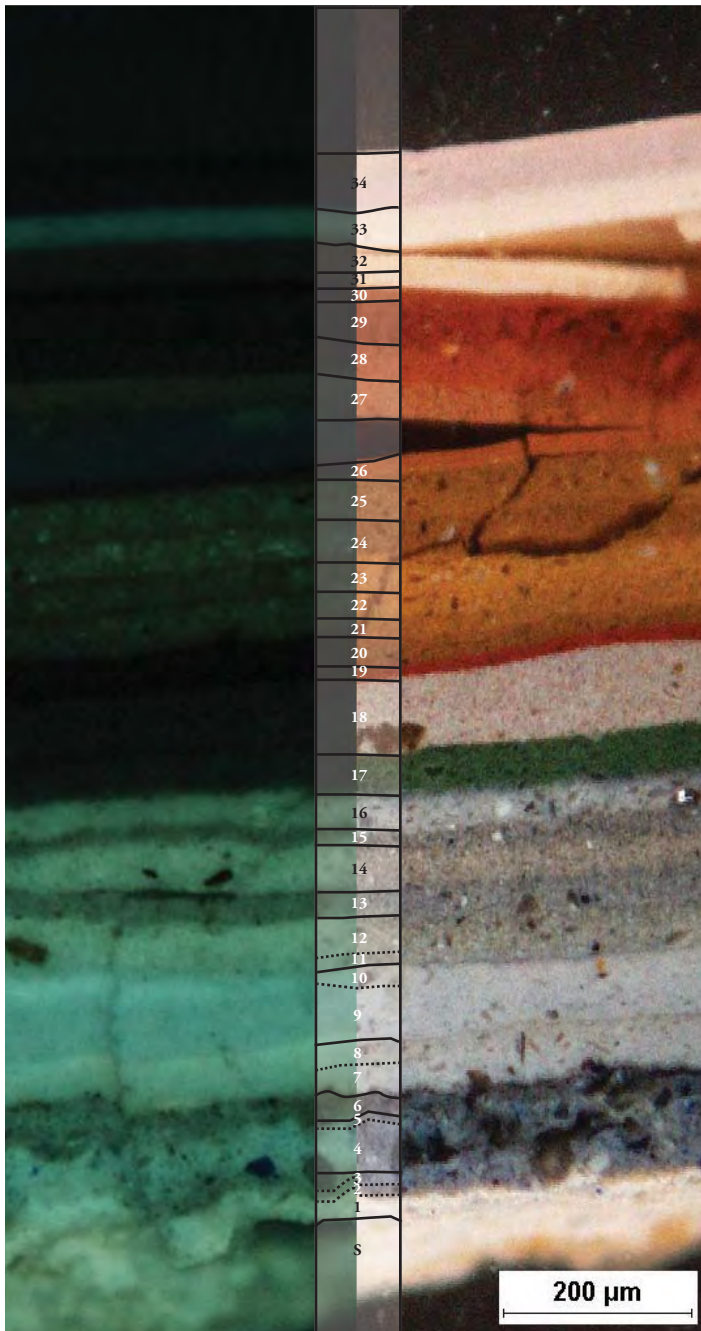
Sample Number: 4 :B: 3	Element: building base	Date Sampled: 02/13/11
Sample Location: frame		Date Analyzed: 03/25/11
Substrate: wood	Illumination: Fluorescence BV 1A, Reflected/Quartz Halogen	
Microscope: Nikon ALPHAPHOT2-YS2		Objective: 4x
Analysis Performed by: Betty Prime		Camera: Nikon DS-Fi1

Stratigraphy

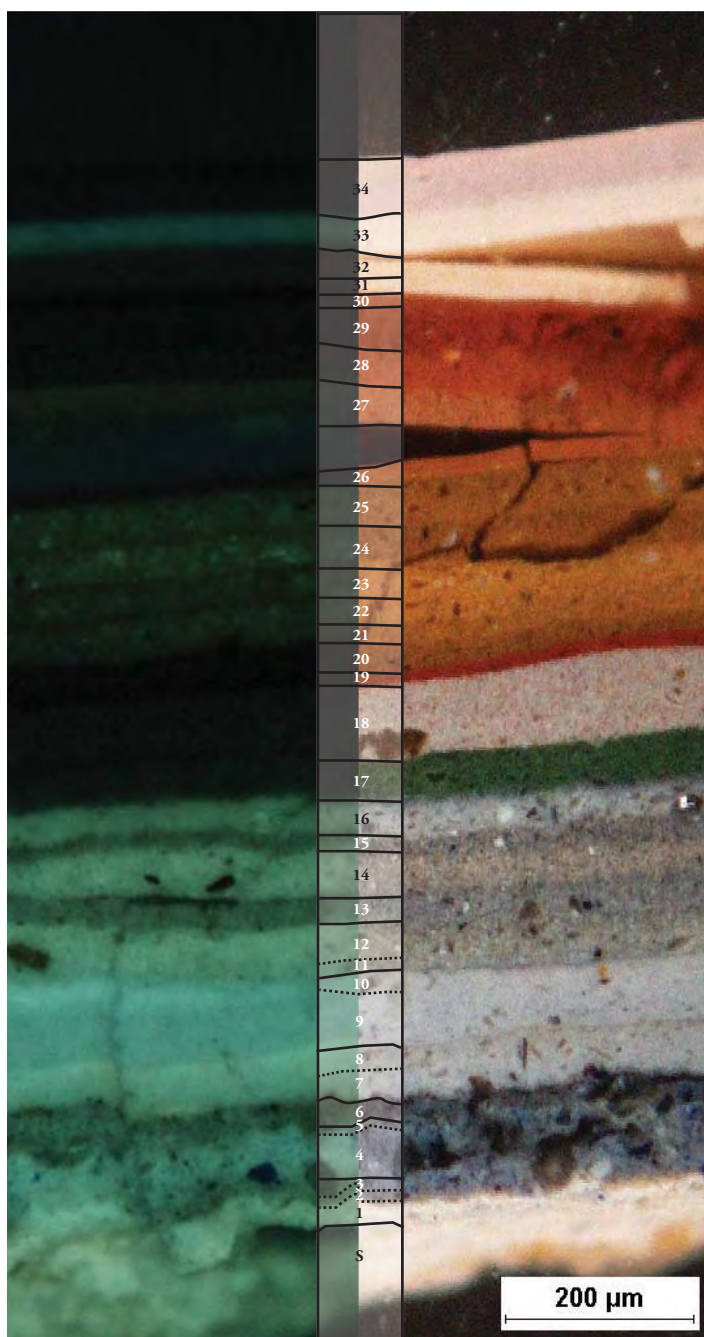
Sample Number: 4 :B: 3	Element: building base	Date Sampled: 02/13/11
Sample Location: frame		Date Analyzed: 03/25/11
Substrate: wood	Illumination: Fluorescence BV 1A, Reflected/Quartz Halogen	
Microscope: Nikon ALPHAPHOT2-YS2		Objective: 4x
Analysis Performed by: Betty Prime		Camera: Nikon DS-Fi1

Stratigraphy

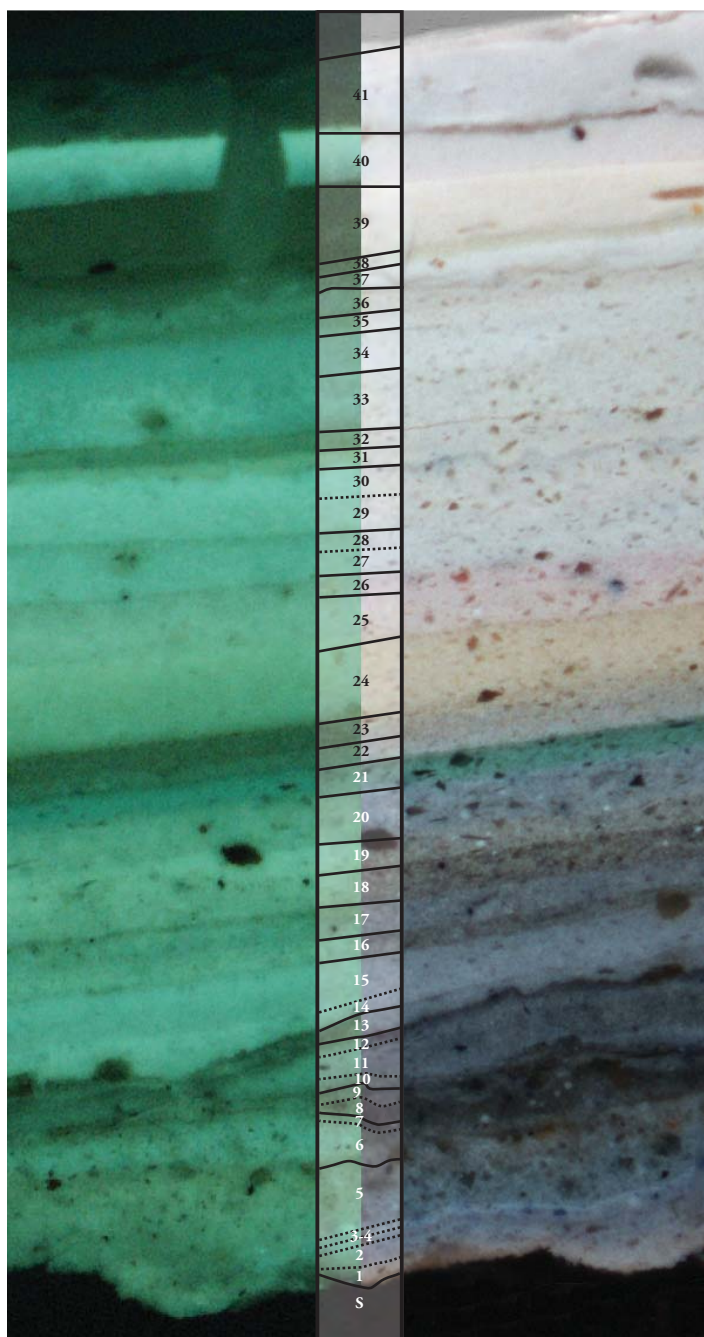
Sample Number: 4 :B: 4	Element: building base	Date Sampled: 02/13/11
Sample Location: middle panel		Date Analyzed: 03/25/11
Substrate: wood	Illumination: Fluorescence BV 1A, Reflected/Quartz Halogen	
Microscope: Nikon ALPHAPHOT2-YS2		Objective: 4x
Analysis Performed by: Betty Prime		Camera: Nikon DS-Fi1

Stratigraphy

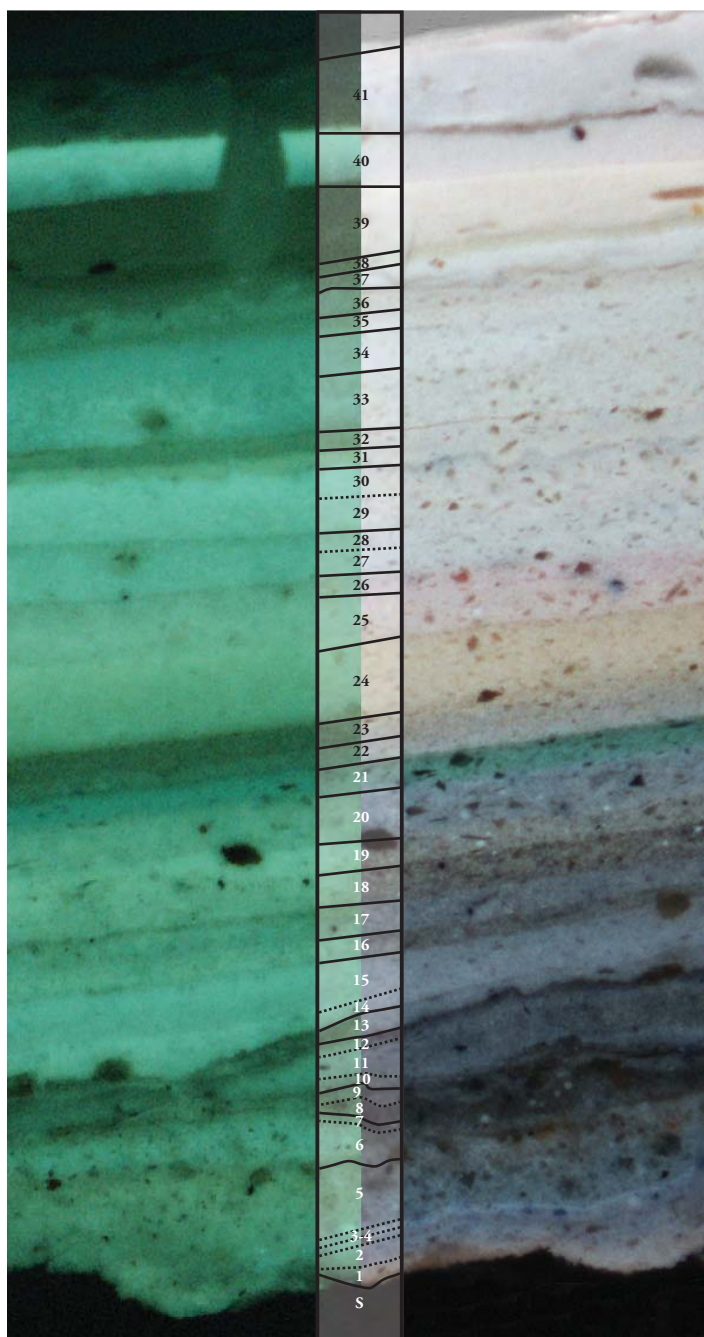
Sample Number: 4 :B: 4	Element: building base	Date Sampled: 02/13/11
Sample Location: middle panel		Date Analyzed: 03/25/11
Substrate: wood	Illumination: Fluorescence BV 1A, Reflected/Quartz Halogen	
Microscope: Nikon ALPHAPHOT2-YS2		Objective: 4x
Analysis Performed by: Betty Prime		Camera: Nikon DS-Fi1

Stratigraphy

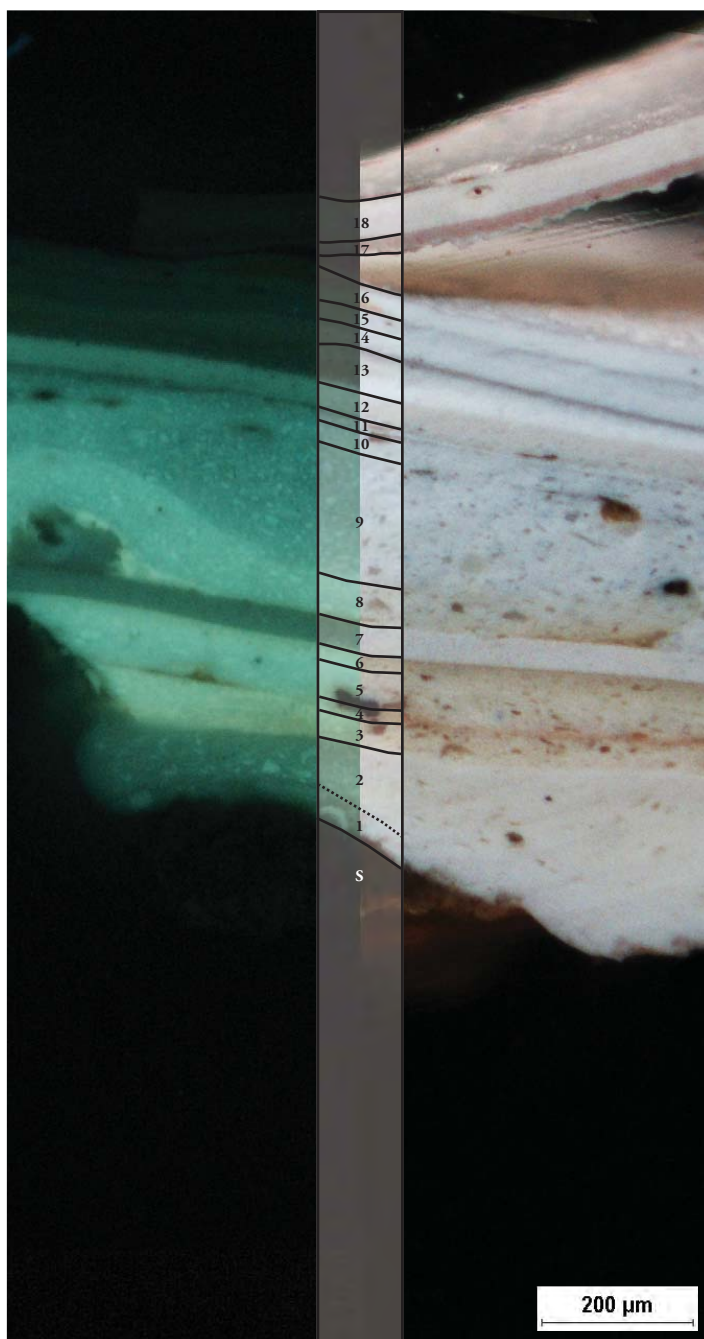
Sample Number: 4 :C: 2	Element: column	Date Sampled: 02/13/11
Sample Location: east, bottom		Date Analyzed: 03/25/11
Substrate: wood	Illumination: Fluorescence BV 1A, Reflected/Quartz Halogen	
Microscope: Nikon ALPHAPHOT2-YS2		Objective: 4x
Analysis Performed by: Betty Prime		Camera: Nikon DS-Fi1

Stratigraphy

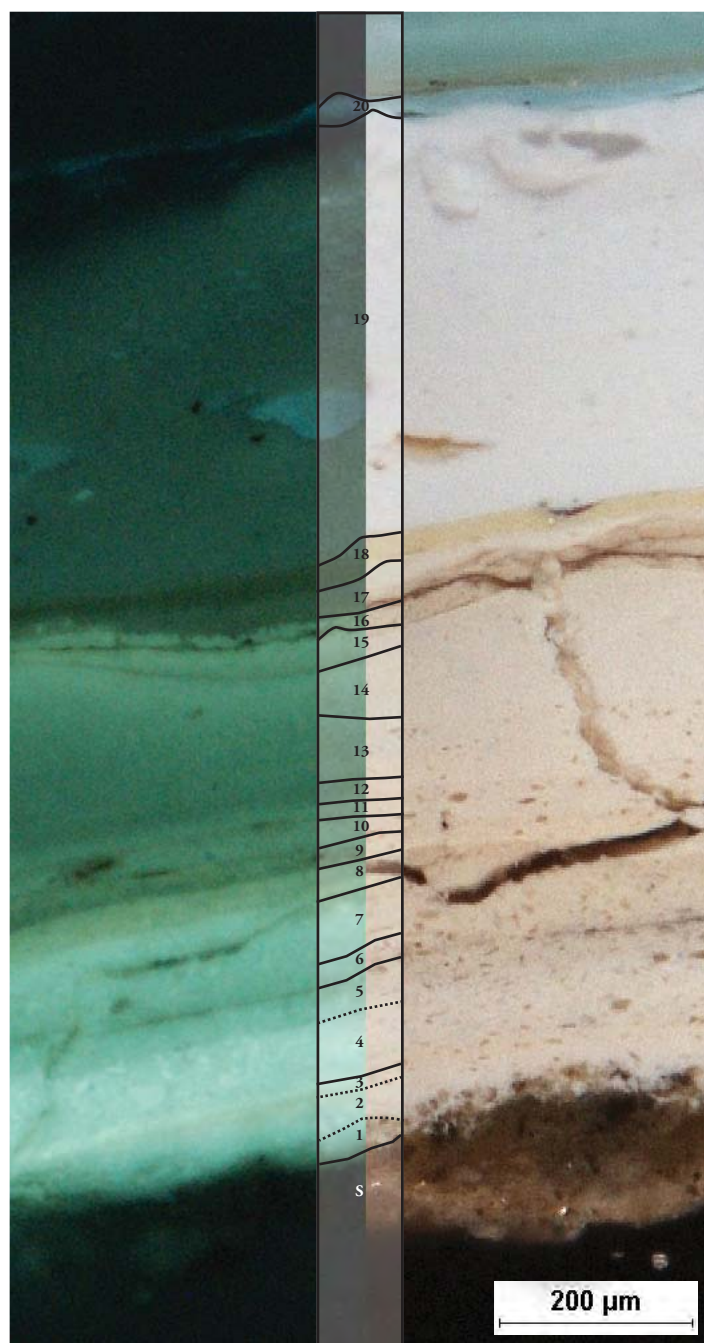
Sample Number: 4 :D: 1	Element: porch railing	Date Sampled: 02/13/11
Sample Location: balustrade		Date Analyzed: 03/25/11
Substrate: wood	Illumination: Fluorescence BV 1A, Reflected/Quartz Halogen	
Microscope: Nikon ALPHAPHOT2-YS2		Objective: 4x
Analysis Performed by: Betty Prime		Camera: Nikon DS-Fi1

Stratigraphy

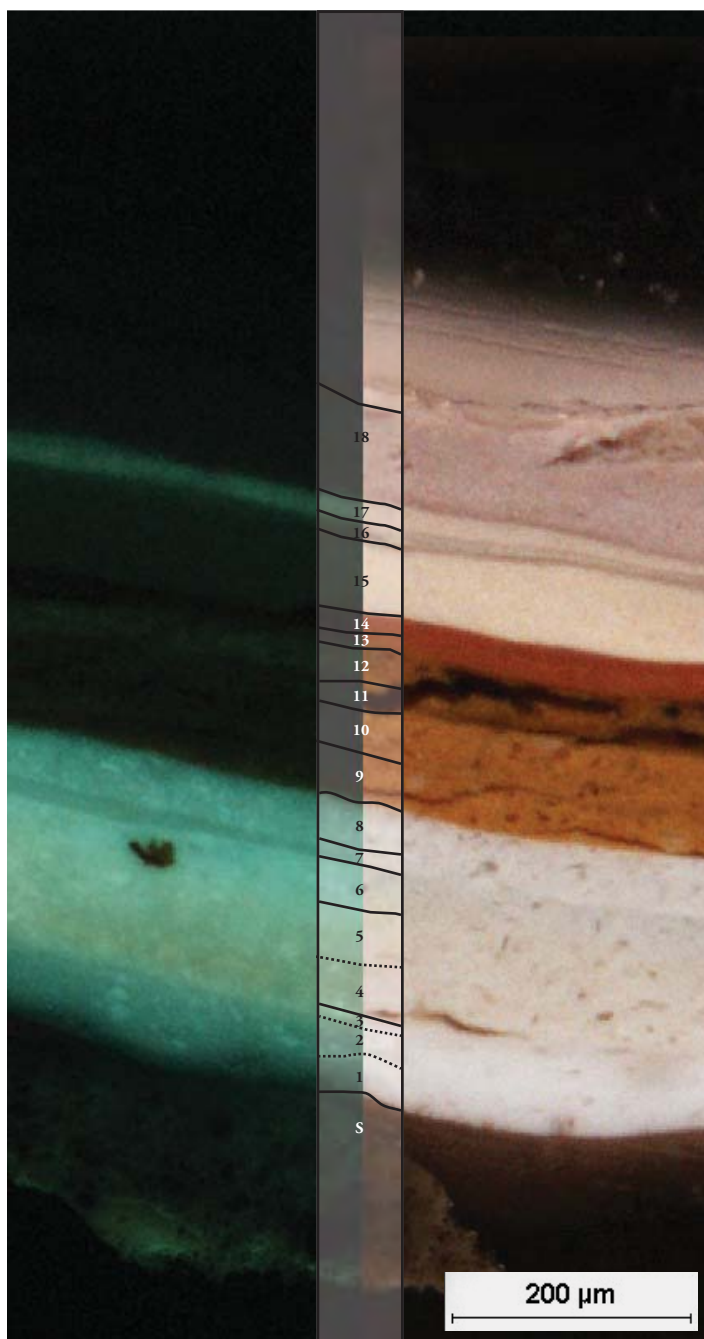
Guayama, Puerto Rico
4 E. Cecelio Dominguez Street

Sample Number: 4 :E: 1	Element: porch handrail	Date Sampled: 02/13/11
Sample Location: underside, interior side		Date Analyzed: 03/25/11
Substrate: wood	Illumination: Fluorescence BV 1A, Reflected/Quartz Halogen	
Microscope: Nikon ALPHAPHOT2-YS2		Objective: 4x
Analysis Performed by: Betty Prime		Camera: Nikon DS-Fi1

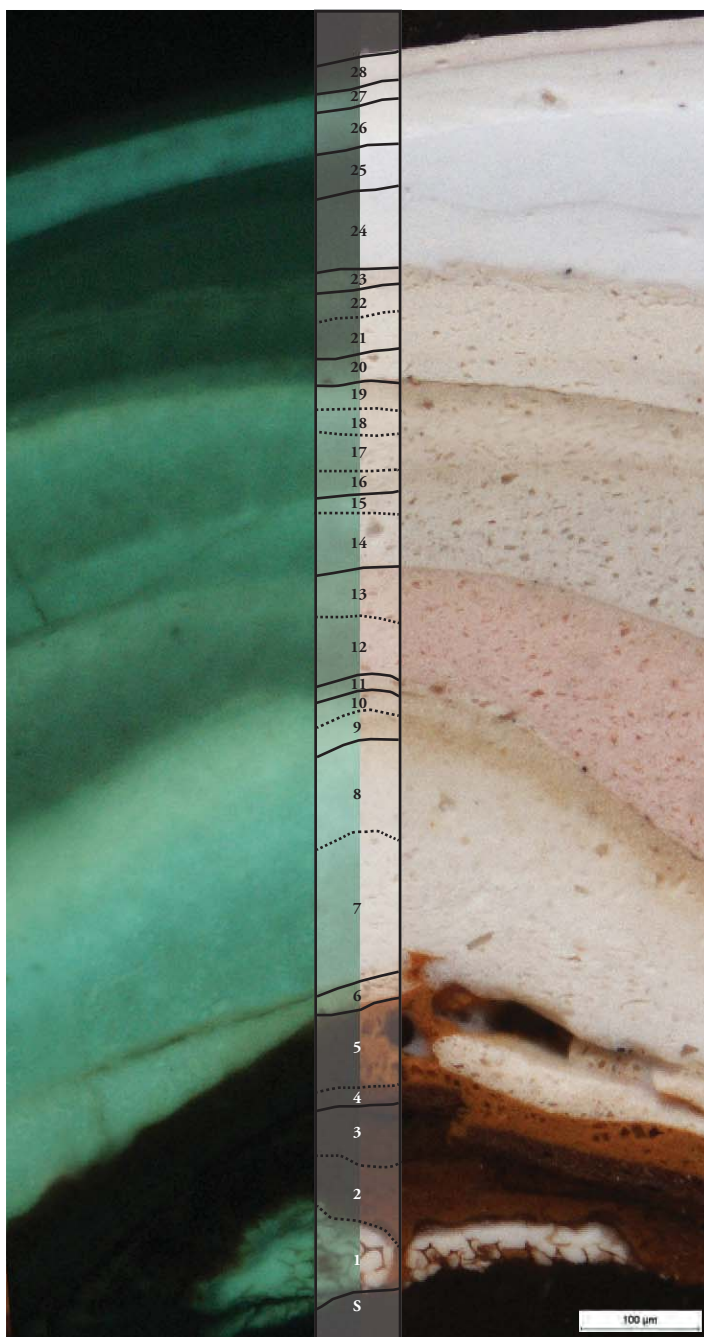
Guayama, Puerto Rico
4 E. Cecelio Dominguez Street

Sample Number: 4 :F: 4	Element: door	Date Sampled: 02/13/11
Sample Location: main panel, center frame		Date Analyzed: 03/25/11
Substrate: wood	Illumination: Fluorescence BV 1A, Reflected/Quartz Halogen	
Microscope: Nikon ALPHAPHOT2-YS2		Objective: 10x
Analysis Performed by: Betty Prime		Camera: Nikon DS-Fi1

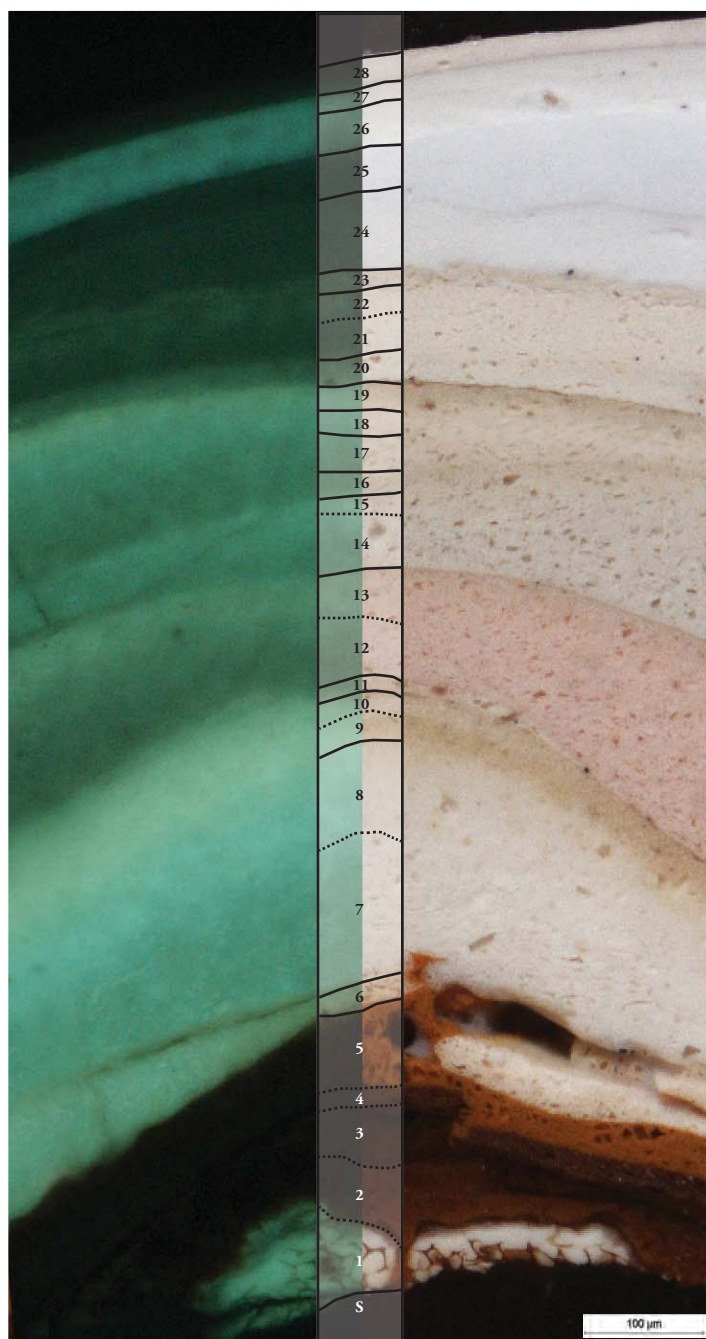
Guayama, Puerto Rico
4 E. Cecelio Dominguez Street

Sample Number: 4 :F: 4	Element: door	Date Sampled: 02/13/11
Sample Location: main panel, center frame		Date Analyzed: 03/25/11
Substrate: wood	Illumination: Fluorescence BV 1A, Reflected/Quartz Halogen	
Microscope: Nikon ALPHAPHOT2-YS2		Objective: 10x
Analysis Performed by: Betty Prime		Camera: Nikon DS-Fi1

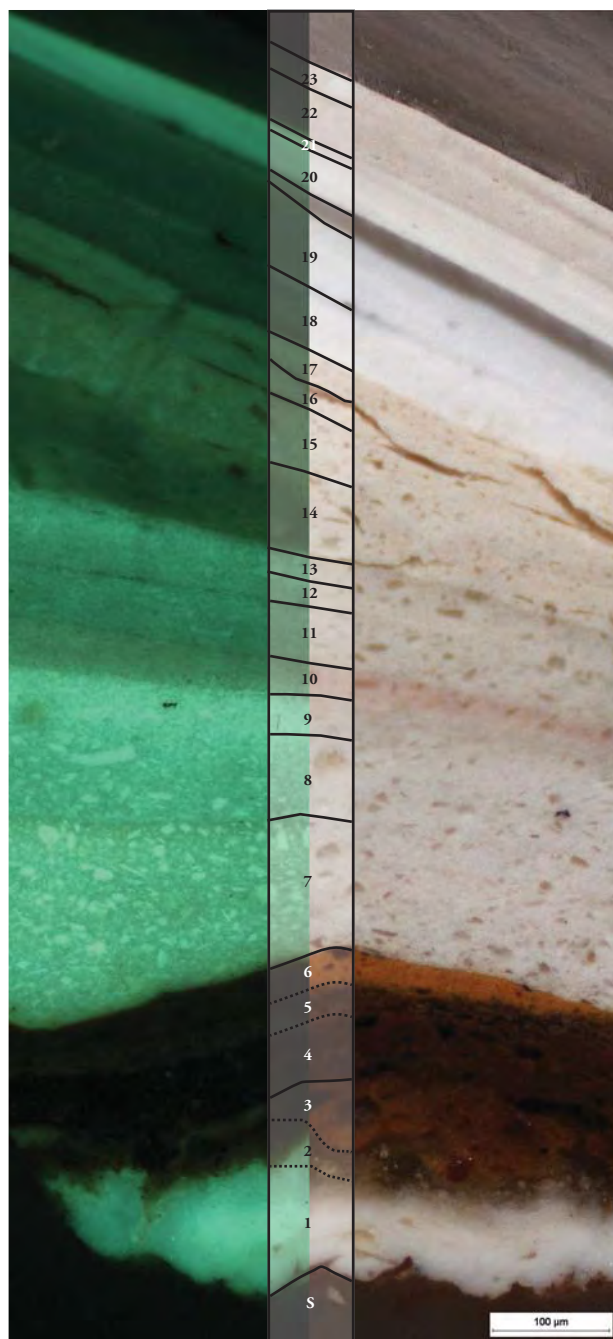
Guayama, Puerto Rico
4 E. Cecelio Dominguez Street

Sample Number: 4 :F: 3	Element: door	Date Sampled: 02/13/11
Sample Location: panel		Date Analyzed: 03/25/11
Substrate: wood	Illumination: Fluorescence BV 1A, Reflected/Quartz Halogen	
Microscope: Nikon ALPHAPHOT2-YS2		Objective: 10x
Analysis Performed by: Betty Prime		Camera: Nikon DS-Fi1

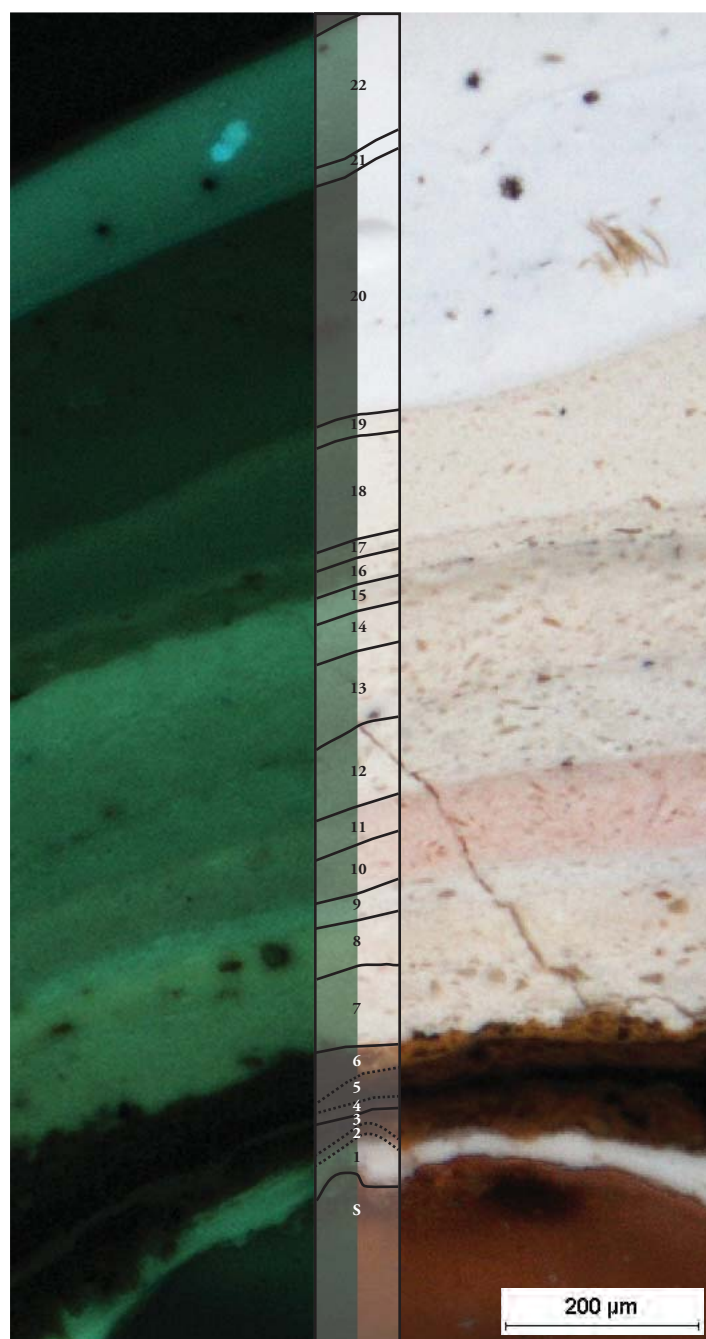
Guayama, Puerto Rico
4 E. Cecelio Dominguez Street

Sample Number: 48 :F: 8	Element: door	Date Sampled: 02/13/11
Sample Location: shutter		Date Analyzed: 03/25/11
Substrate: wood	Illumination: Fluorescence BV 1A, Reflected/Quartz Halogen	
Microscope: Nikon ALPHAPHOT2-YS2		Objective: 4x
Analysis Performed by: Betty Prime		Camera: Nikon DS-Fi1

Scheme/Layer		Color
20	22	off white
19	21	off white
18	20	*white
17	19	/*light tan
16	18	cream
15	17	cream
14	16	*light tan
13	15	*tan
12	14	cream
11	13	cream
10	12	*off white
9	11	*pink
8	10	pink
7	9	off white
6	8	cream
5	7	cream
4	6	*brown orange
3	5	red brown
2	4	dark brown
1	3	red brown
	2	translucent gold
	1	white
		substrate

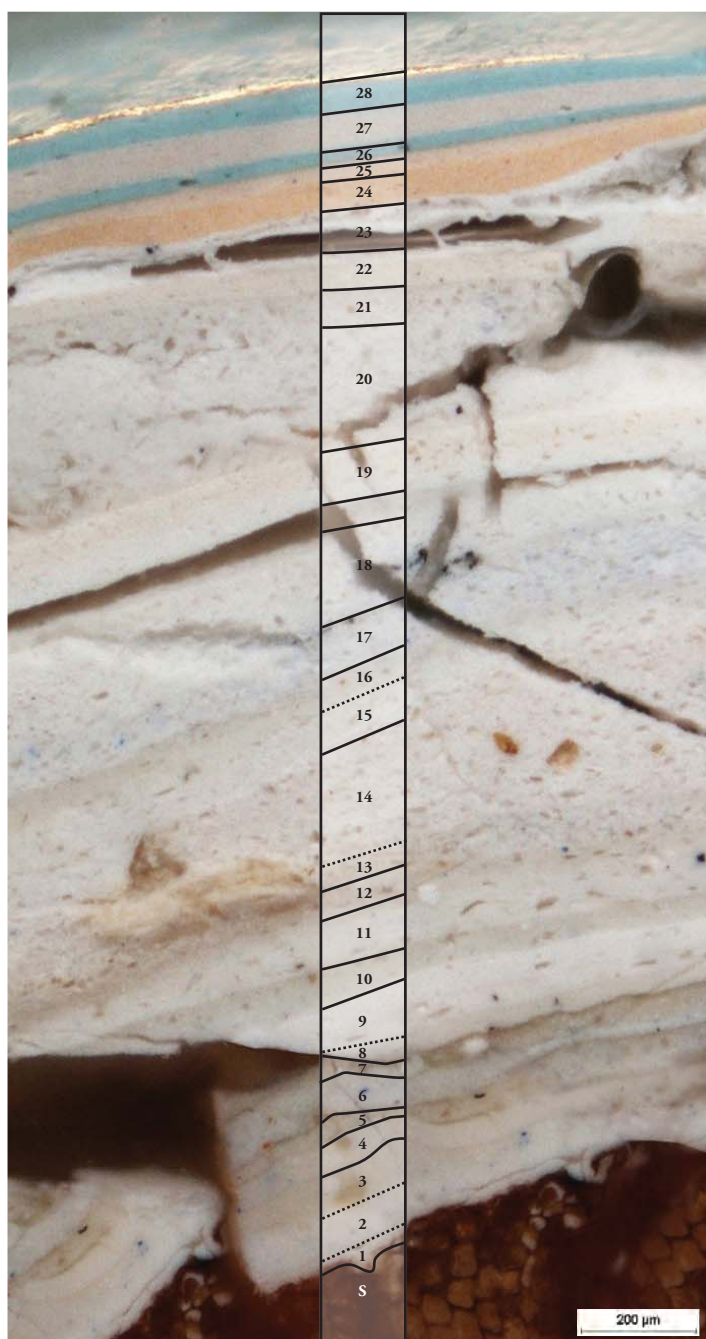
Guayama, Puerto Rico
4 E. Cecelio Dominguez Street

Sample Number: 4 :G: 3	Element: door frame	Date Sampled: 02/13/11
Sample Location: horizontal divider, central Door		Date Analyzed: 03/25/11
Substrate: wood	Illumination: Fluorescence BV 1A, Reflected/Quartz Halogen	
Microscope: Nikon ALPHAPHOT2-YS2		Objective: 4x
Analysis Performed by: Betty Prime		Camera: Nikon DS-Fi1

Scheme/Layer		Color
20	25	light yellow
19	24	orange yellow
18	23	/*white
17	22	cream
16	21	light tan
15	20	off white
14	19	cream
13	18	/light cream
12	17	off white
11	16	light tan
	15	light cream
10	14	off white
	13	light tan
9	12	tan
8	11	light tan
7	10	off white
	9	off white
6	8	off white
	7	*tan
4	6	*white
3	5	off white
2	4	*off white
1	3	*white
	2	white
	1	white
		substrate

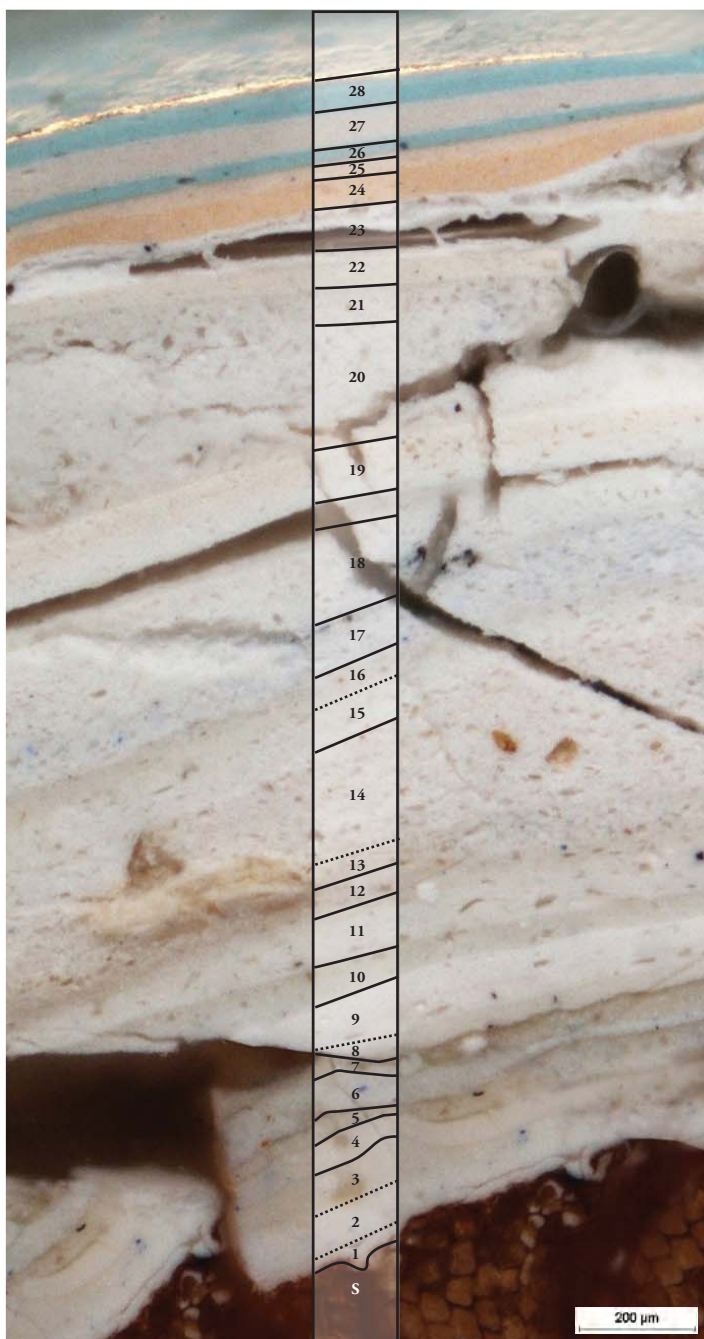
Guayama, Puerto Rico
4 E. Cecelio Dominguez Street

Sample Number: 4 :G: 3	Element: door frame	Date Sampled: 02/13/11
Sample Location: horizontal divider, central Door		Date Analyzed: 03/25/11
Substrate: wood	Illumination: Fluorescence BV 1A, Reflected/Quartz Halogen	
Microscope: Nikon ALPHAPHOT2-YS2		Objective: 4x
Analysis Performed by: Betty Prime		Camera: Nikon DS-Fi1

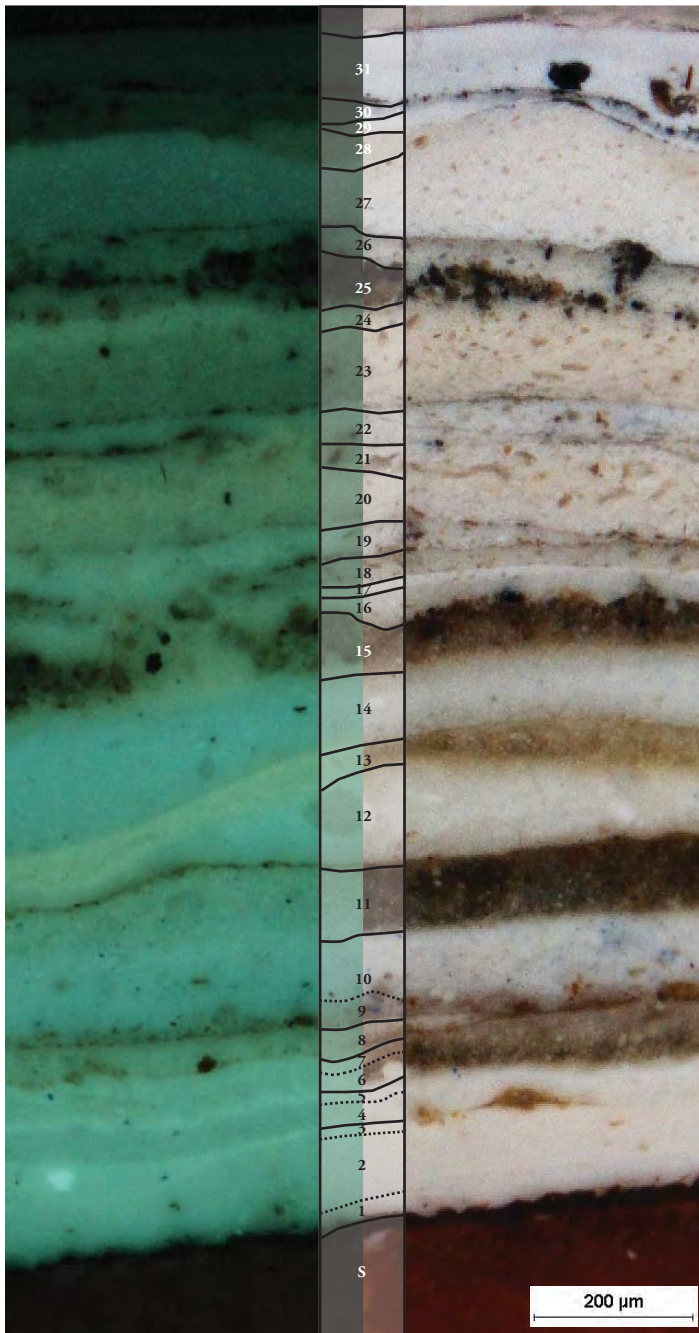
Guayama, Puerto Rico
4 E. Cecelio Dominguez Street

Sample Number: 4 :G: 4	Element: door frame	Date Sampled: 02/13/11
Sample Location: panel above main door		Date Analyzed: 03/25/11
Substrate: wood	Illumination: Fluorescence BV 1A, Reflected/Quartz Halogen	
Microscope: Nikon ALPHAPHOT2-YS2		Objective: 4x
Analysis Performed by: Betty Prime		Camera: Nikon DS-Fi1

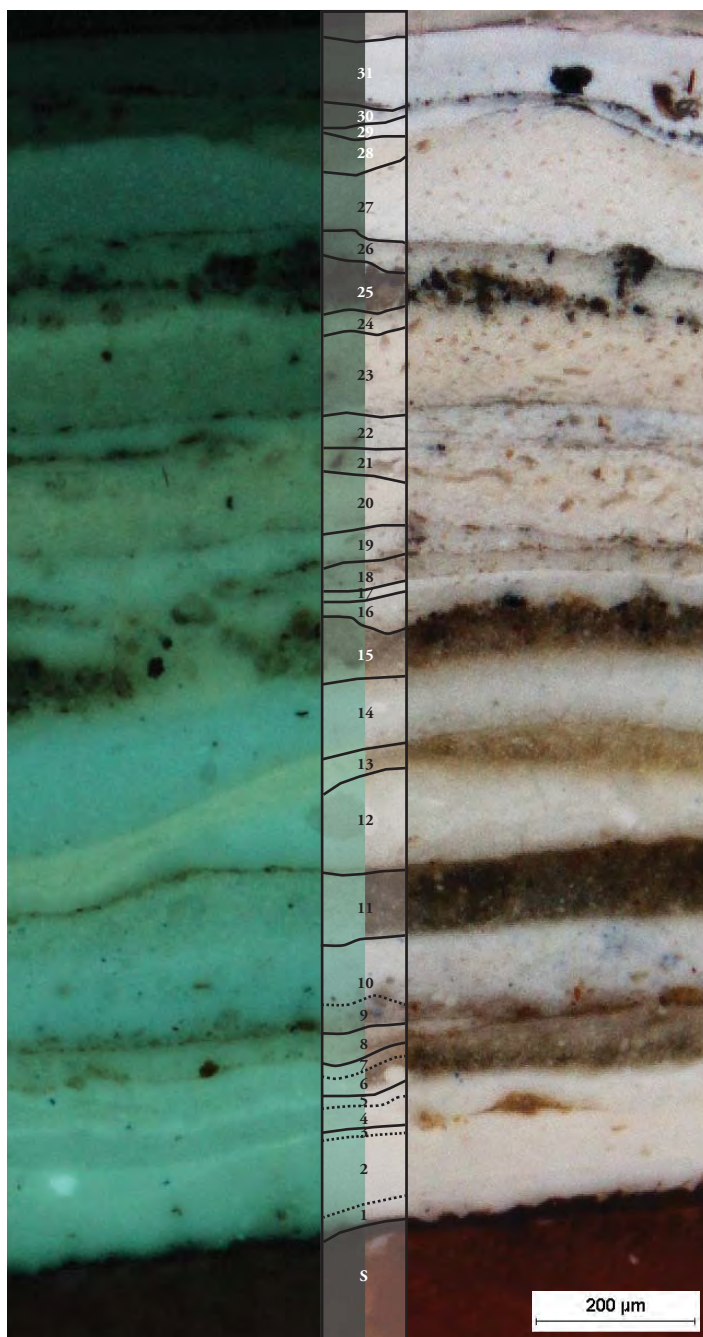
Guayama, Puerto Rico
4 E. Cecelio Dominguez Street

Sample Number: 4 :G: 4	Element: door frame	Date Sampled: 02/13/11
Sample Location: panel above main door		Date Analyzed: 03/25/11
Substrate: wood	Illumination: Fluorescence BV 1A, Reflected/Quartz Halogen	
Microscope: Nikon ALPHAPHOT2-YS2		Objective: 4x
Analysis Performed by: Betty Prime		Camera: Nikon DS-Fi1

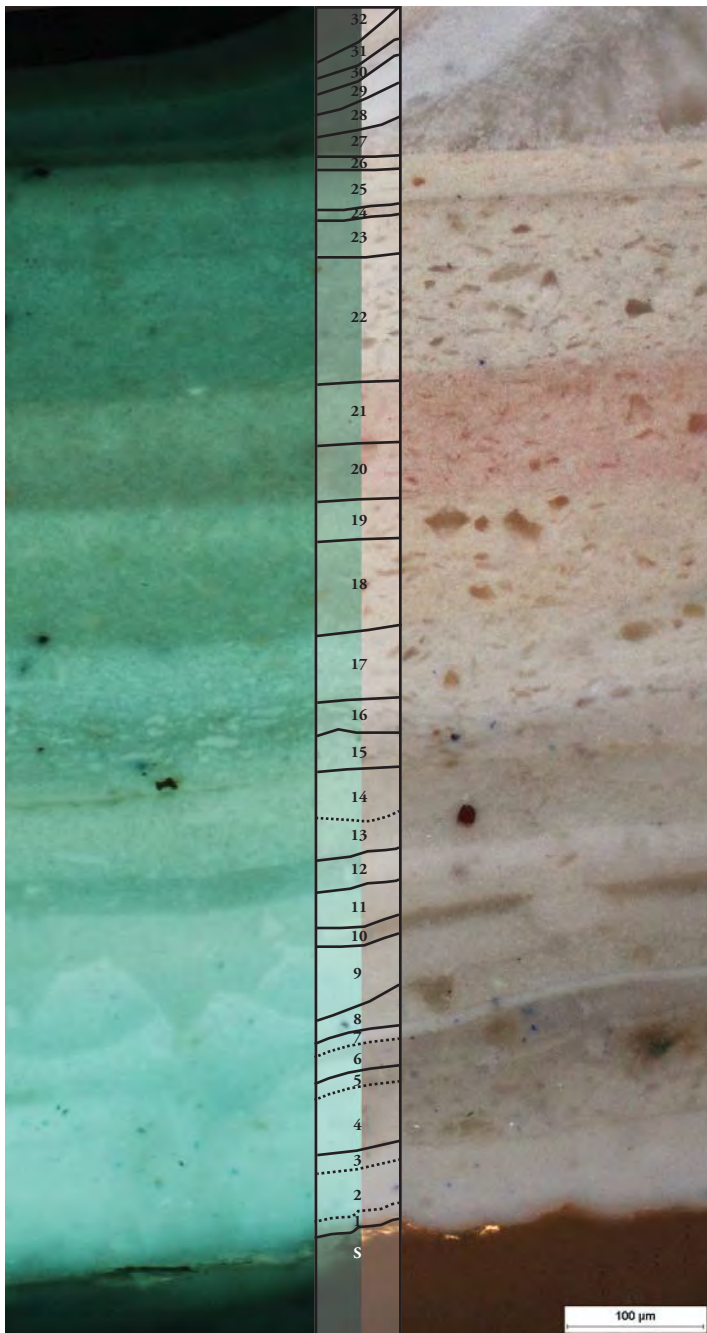
Guayama, Puerto Rico
4 E. Cecelio Dominguez Street

Sample Number: 4 :G: 10	Element: door frame	Date Sampled: 02/13/11
Sample Location: main door, transom		Date Analyzed: 03/25/11
Substrate: wood	Illumination: Fluorescence BV 1A, Reflected/Quartz Halogen	
Microscope: Nikon ALPHAPHOT2-YS2		Objective: 10x
Analysis Performed by: Betty Prime		Camera: Nikon DS-Fi1

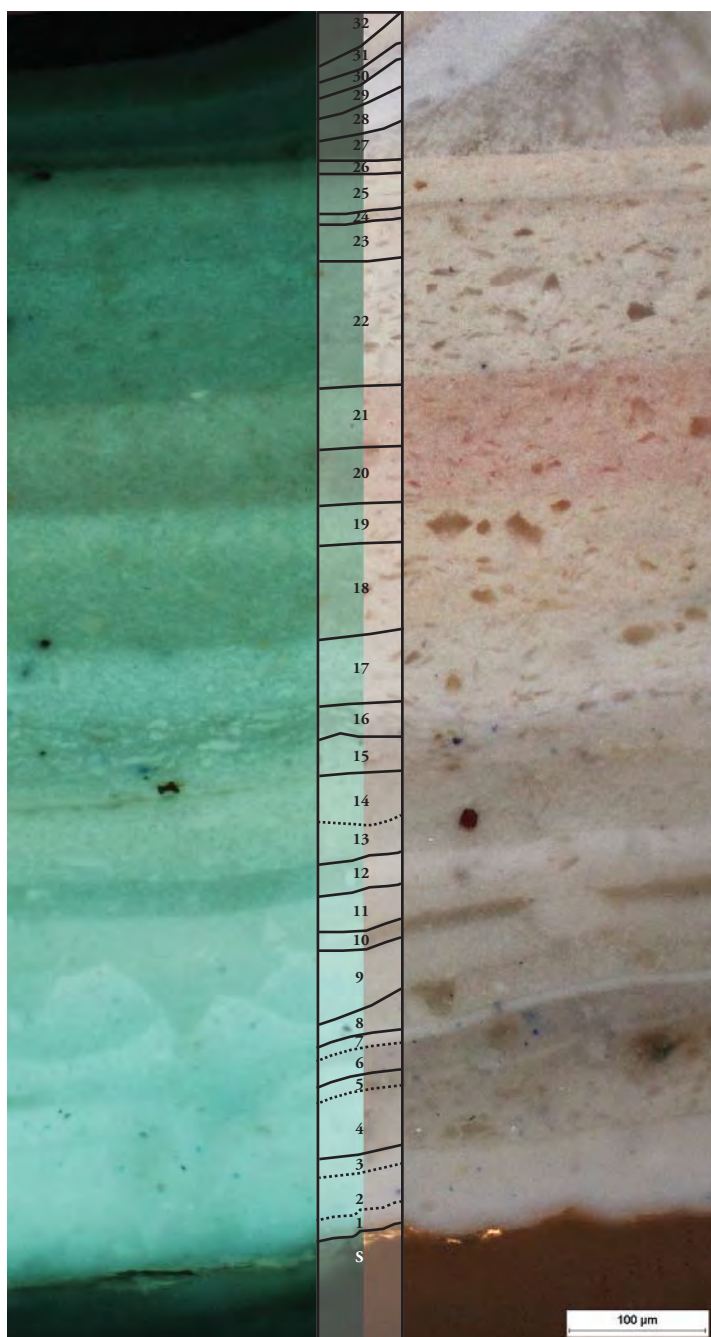
Guayama, Puerto Rico
4 E. Cecelio Dominguez Street

Sample Number: 4 :G: 10	Element: door frame	Date Sampled: 02/13/11
Sample Location: main door, transom		Date Analyzed: 03/25/11
Substrate: wood	Illumination: Fluorescence BV 1A, Reflected/Quartz Halogen	
Microscope: Nikon ALPHAPHOT2-YS2		Objective: 10x
Analysis Performed by: Betty Prime		Camera: Nikon DS-Fi1

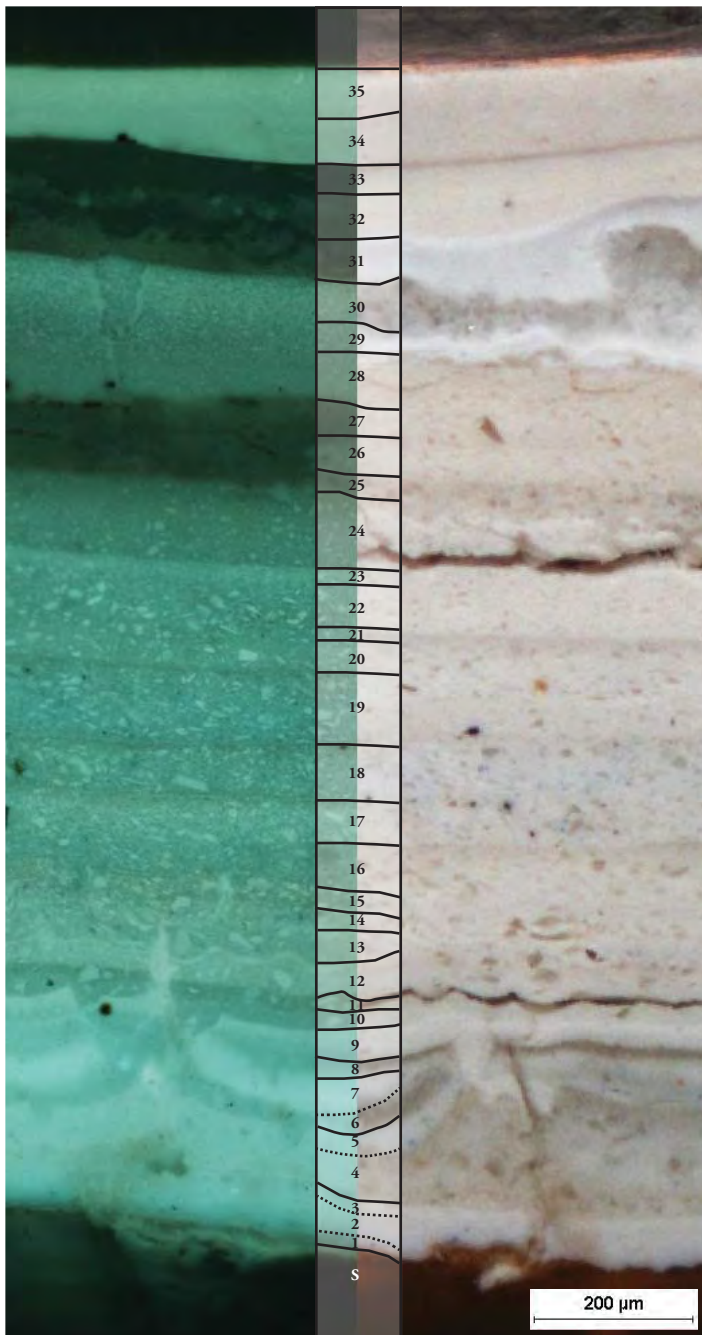
Guayama, Puerto Rico
4 E. Cecelio Dominguez Street

Sample Number: 4 :G: 11	Element: door frame	Date Sampled: 02/13/11
Sample Location: pediment trim below top		Date Analyzed: 03/25/11
Substrate: wood	Illumination: Fluorescence BV 1A, Reflected/Quartz Halogen	
Microscope: Nikon ALPHAPHOT2-YS2		Objective: 4x
Analysis Performed by: Betty Prime		Camera: Nikon DS-Fi1

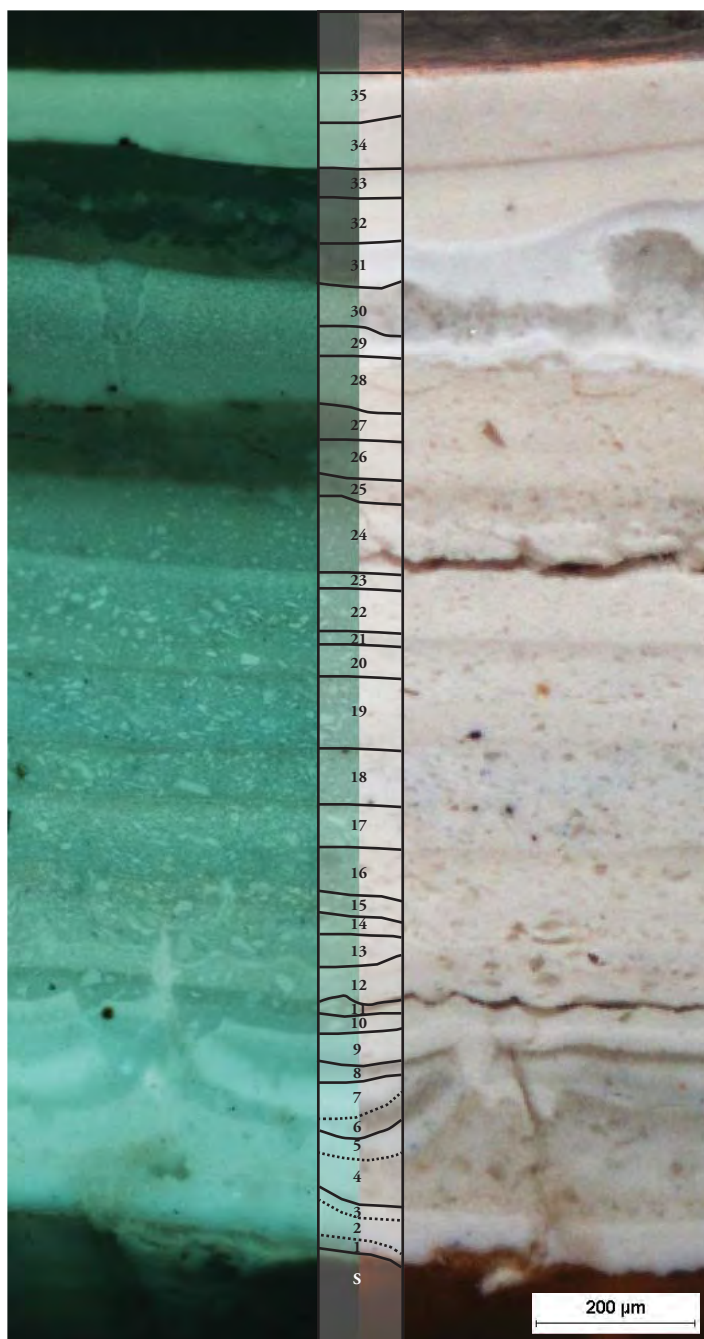
Guayama, Puerto Rico
4 E. Cecelio Dominguez Street

Sample Number: 4 :G: 11	Element: door frame	Date Sampled: 02/13/11
Sample Location: pediment trim below top		Date Analyzed: 03/25/11
Substrate: wood	Illumination: Fluorescence BV 1A, Reflected/Quartz Halogen	
Microscope: Nikon ALPHAPHOT2-YS2		Objective: 4x
Analysis Performed by: Betty Prime		Camera: Nikon DS-Fi1

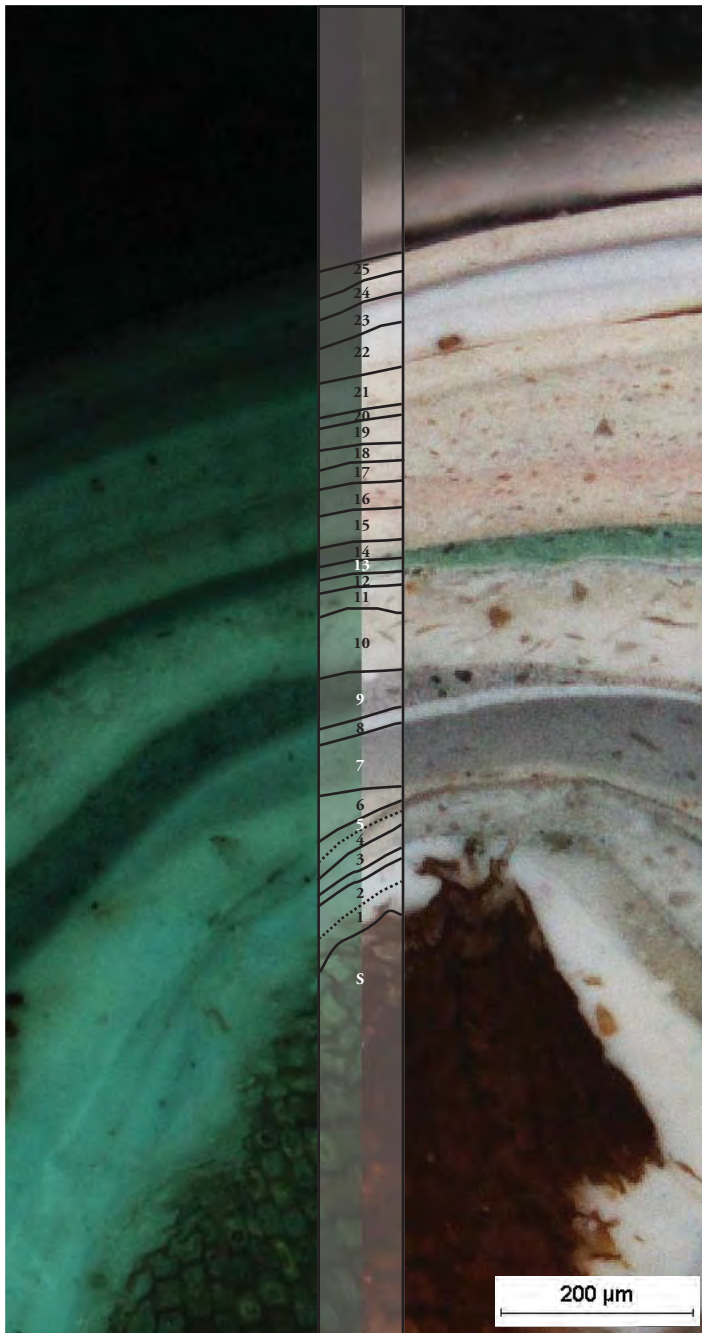
Guayama, Puerto Rico
4 E. Cecelio Dominguez Street

Sample Number: 4 :G: 12	Element: door frame	Date Sampled: 02/13/11
Sample Location: sidelight inner panel		Date Analyzed: 03/25/11
Substrate: wood	Illumination: Fluorescence BV 1A, Reflected/Quartz Halogen	
Microscope: Nikon ALPHAPHOT2-YS2		Objective: 4x
Analysis Performed by: Betty Prime		Camera: Nikon DS-Fi1

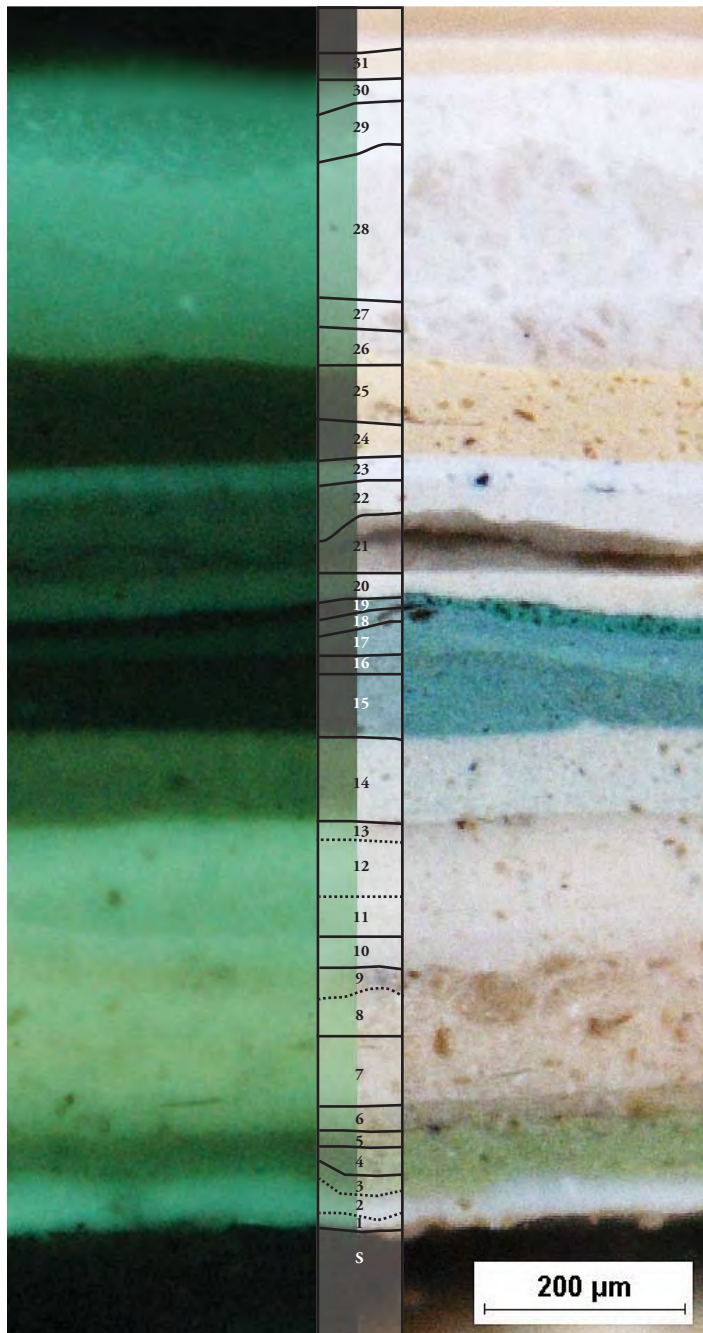
Guayama, Puerto Rico
6 E. Cecelio Dominguez Street

Sample Number: 6 :A: 1	Element: wall	Date Sampled: 02/13/11
Sample Location: siding, west side of main door		Date Analyzed: 04/09/11
Substrate: wood	Illumination: Fluorescence BV 1A, Reflected/Quartz Halogen	
Microscope: Nikon ALPHAPHOT2-YS2		Objective: 4x
Analysis Performed by: Betty Prime		Camera: Nikon DS-Fi1

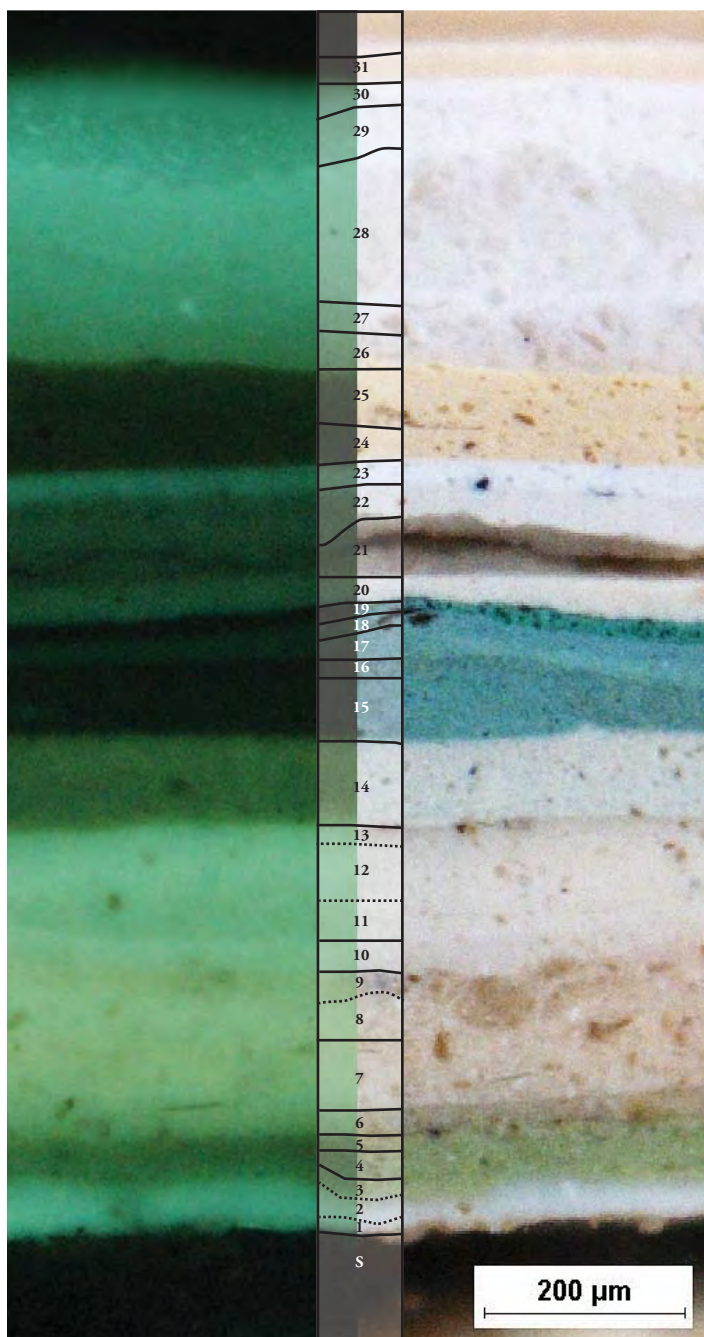
Guayama, Puerto Rico
6 E. Cecelio Dominguez Street

Sample Number: 6 :A: 1	Element: wall	Date Sampled: 02/13/11
Sample Location: siding, west side of main door		Date Analyzed: 04/09/11
Substrate: wood	Illumination: Fluorescence BV 1A, Reflected/Quartz Halogen	
Microscope: Nikon ALPHAPHOT2-YS2		Objective: 4x
Analysis Performed by: Betty Prime		Camera: Nikon DS-Fi1
